**Subject: Building Inspection Summary for November 10 through 12, 2009
Plainwell Mill Site, Operable Unit 7 of
Allied Paper/Portage Creek/Kalamazoo River Site
Plainwell, Kalamazoo County, Michigan
Contract No. EP-S5-06-02, Work Assignment No. 041-RSBD-059B**

**BUILDING INSPECTION SUMMARY
NOVEMBER 10 THROUGH 12, 2009
PLAINWELL MILL SITE, OPERABLE UNIT 7 OF
ALLIED PAPER/PORTAGE CREEK/KALAMAZOO RIVER SITE
PLAINWELL, KALAMAZOO COUNTY, MICHIGAN**

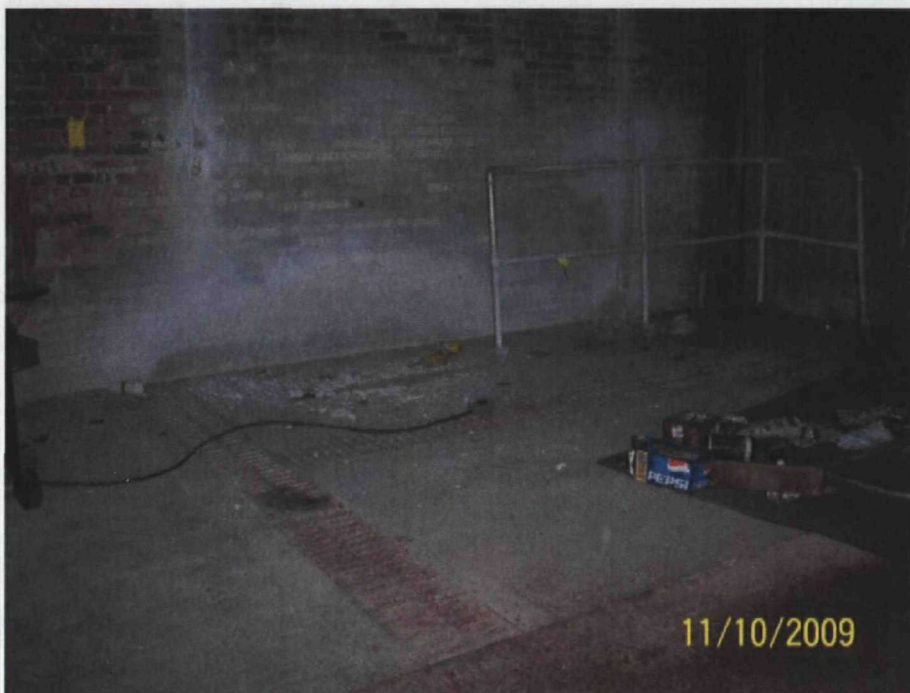
INTERIOR OBSERVATIONS	
Numerous floor drains and manhole grates within the building and in the garage area (see Photograph No. 1 in Appendix A)	
A containment pad with a floor drain inside the building	
EXTERIOR OBSERVATIONS	
A sludge tank behind the main building (see Photograph No. 2 in Appendix A)

Photograph No. 1
 Orientation: Overview
 Description: Floor drains in former wastewater lab.
 Location: Plainwell Mill
 Date: November 10, 2009

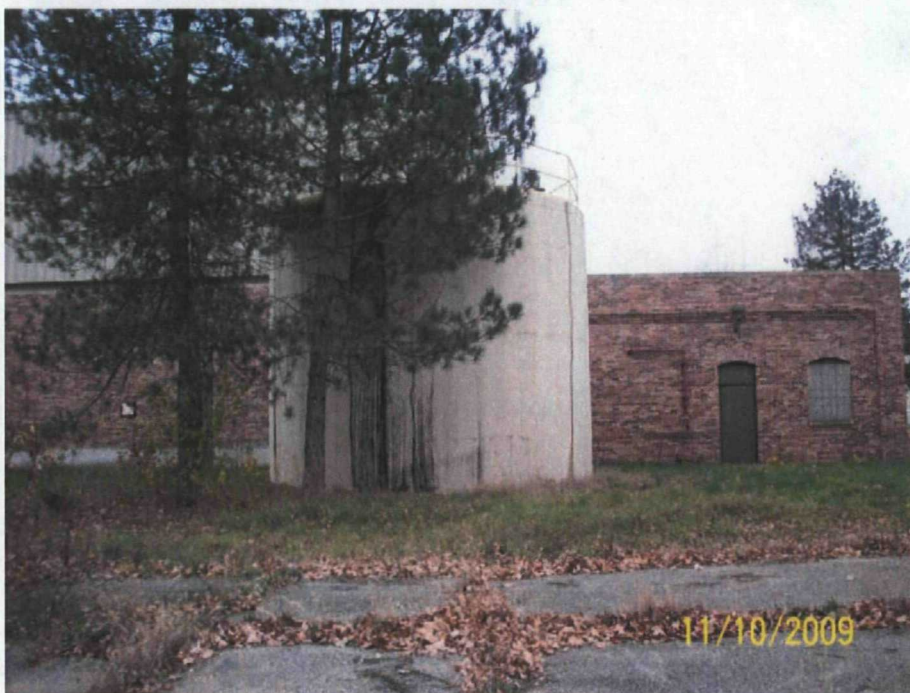
Photograph No. 2
 Orientation: East
 Description: Suspected sludge tank adjacent to former wastewater lab building (view from former Quality Products building).
 Location: Plainwell Mill
 Date: November 10, 2009

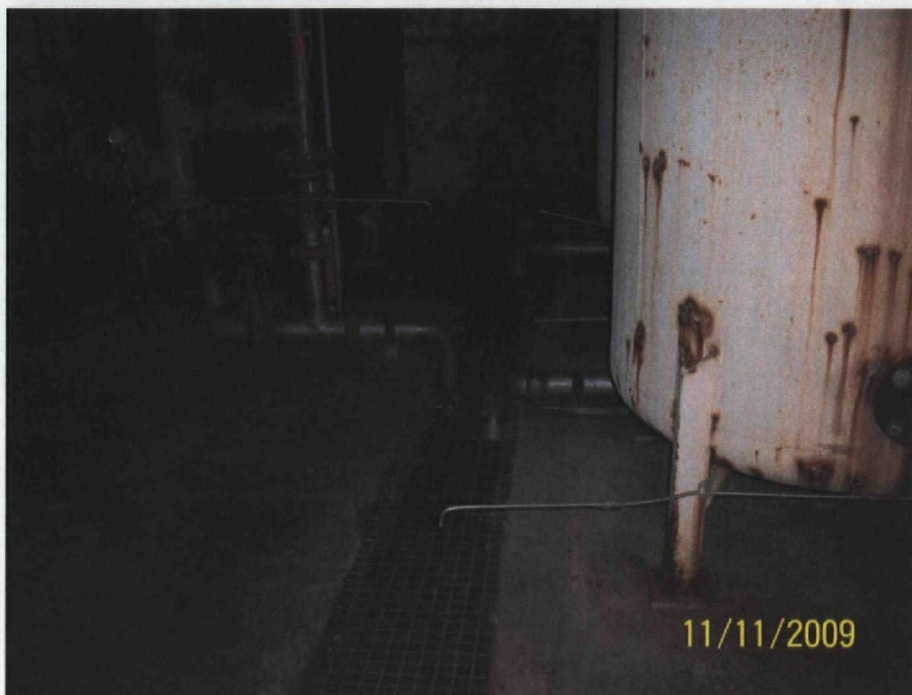
INTERIOR OBSERVATIONS	
An extensive floor drain system throughout the building (see Photograph No. 3 in Appendix A)	
Evidence of oily machine pads and pits (see Photograph No. 4 in Appendix A)	
Areas marked off as "asbestos hazard" (see Photograph No. 5 in Appendix A)	
Numerous tanks and vats present throughout (see Photograph No. 6 in Appendix A)	
Numerous pipes leading into concrete slab—some cut off and some intact	
Evidence of corroded/deteriorated floor drains (Building 5 for example)	
Old sump pits (possible dry wells) that were once outside of the original Mill building (Building 5B/6A) (see Photograph No. 7 in Appendix A)	
Evidence of floor drains leading outside toward the Kalamazoo River (Buildings 3 and 28)	
EXTERIOR OBSERVATIONS	
Manholes possibly leading to outfalls at north side of building leading to river (see Photograph No. 8 in Appendix A)	
Two outfalls located at bank of river	
Evidence of piping and concrete pads—probably former tank locations on north side of building

Description: Floor drains in Mill Building.

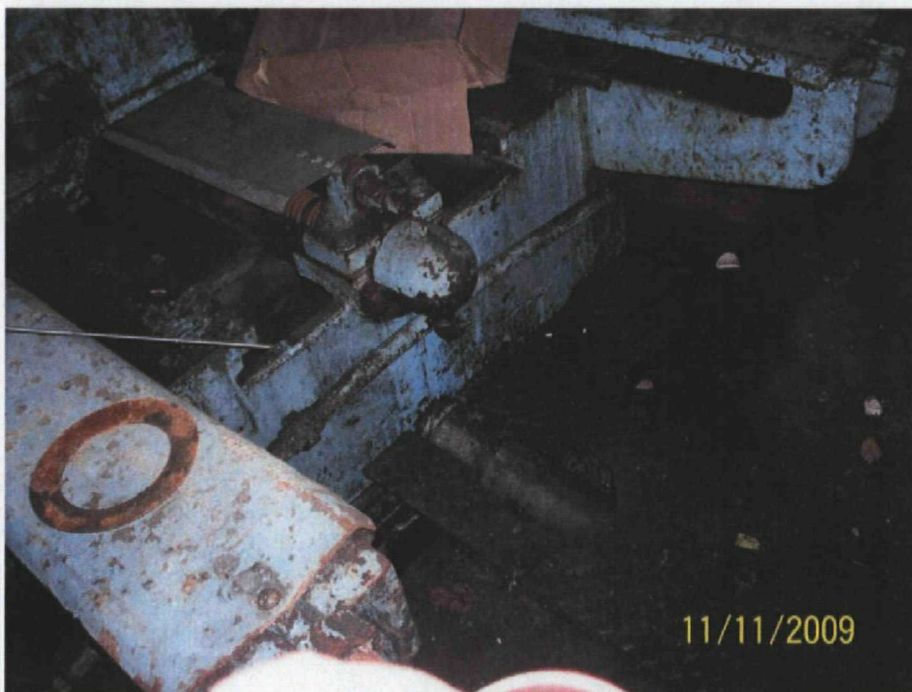
Photograph No. 4

Description: Oily machine pad in Mill Building.

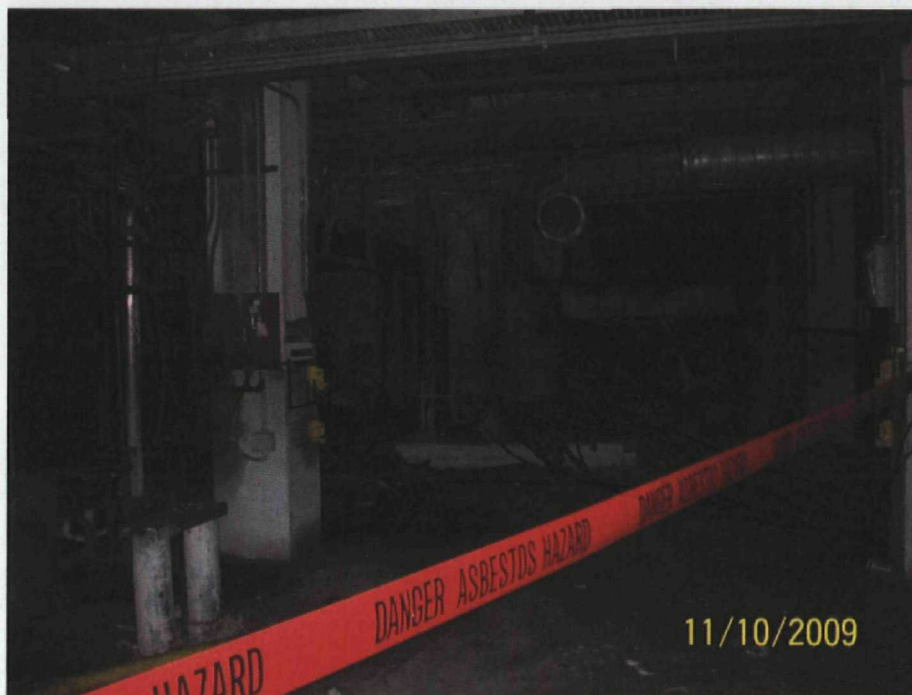
Photograph No. 5

Description: Marked-off asbestos area in Mill Building.

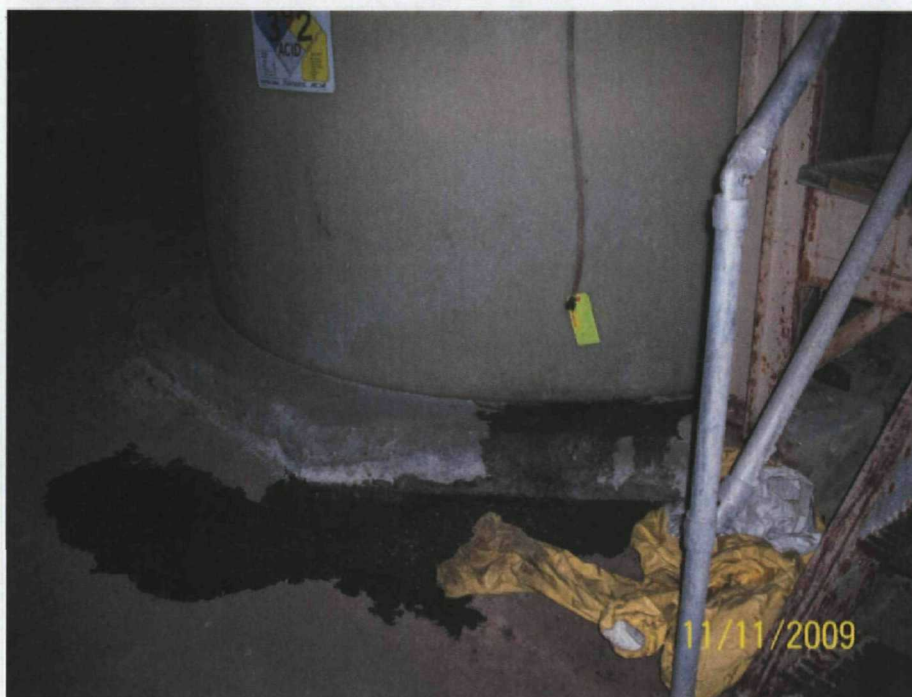
Photograph No. 6

Description: Example of aboveground storage tank in Mill Building.

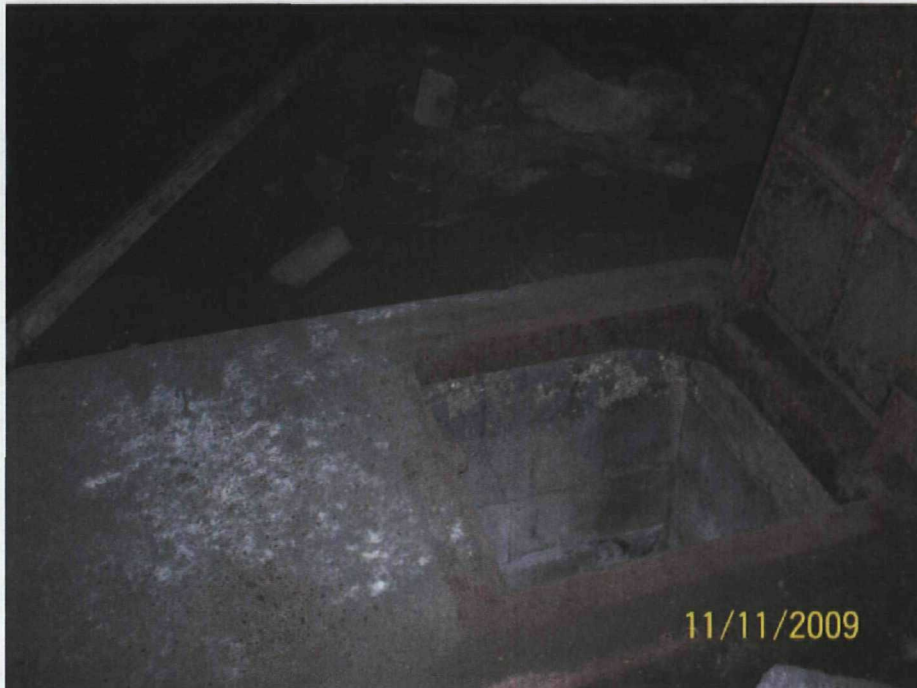
Photograph No. 7
 Orientation: Overview
 Description: One of the old sump pits that had been outside the original Mill building—now inside one of the additions.

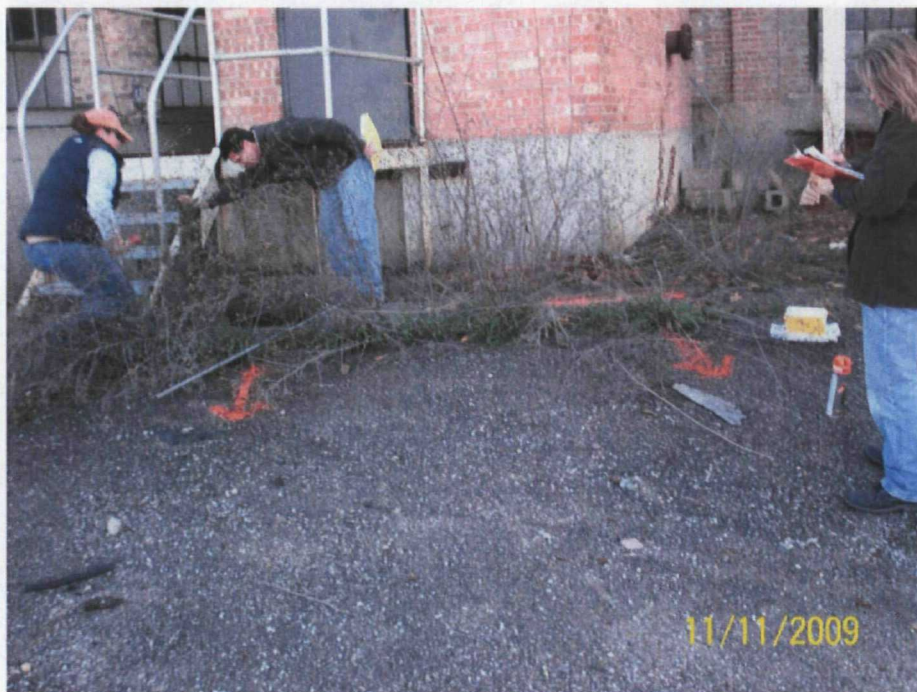
Manholes with pipes connecting from outside and from within the building on north side of building	
Tanks labeled "starch," "aqua ammonia," "clay titanium," and "high and low bright" on west side of building

Photograph No. 8
 Orientation: South
 Description: Manhole with pipes connecting from outside and into the north side of the Mill Building.

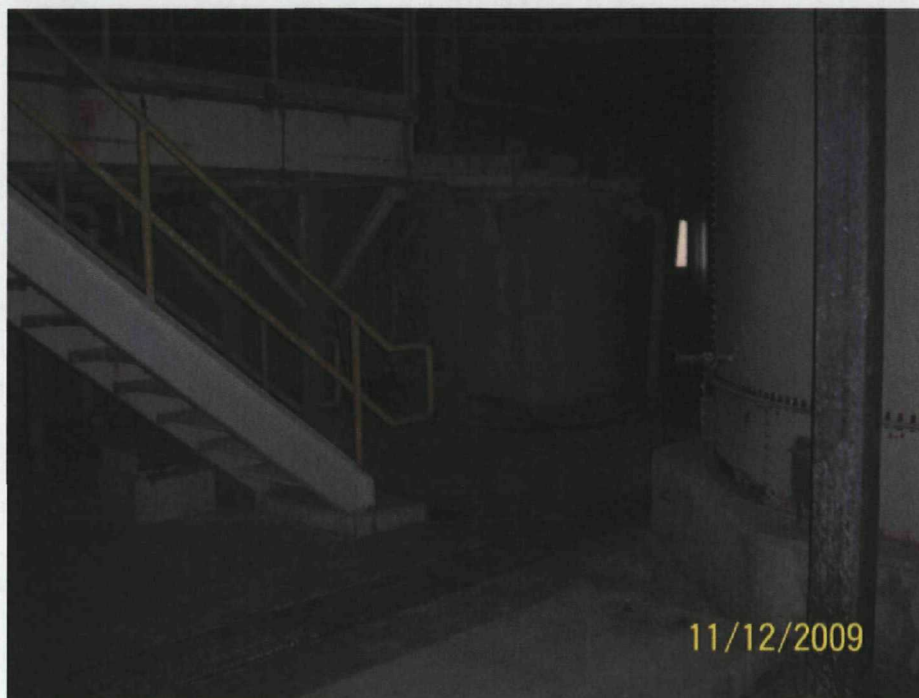
INTERIOR OBSERVATIONS	
An extensive floor drain system throughout the building (see Photograph No. 9 in Appendix A)	
Numerous tanks and vats present throughout—some labeled “calcium carbonate” and “slake,” and some unlabeled	
Numerous pipes leading into concrete slab—some cut off and some intact	
Acid tank station with former tank pad	
Evidence of corroded/deteriorated floor drains (especially near acid tank station) (see Photograph No. 10 in Appendix A)	
Various pipes leading in/out of building marked “cooling water,” “calcium carbonate,” “wastewater,” and “process lines”	
Cut off pipe going out to calcium carbonate silos	
EXTERIOR OBSERVATIONS	
Asphalt “cuts” located at west side of building—possibly for below-grade process lines	
Asphalt “cuts” extending across parking lot toward fuel oil tank area and Mill building (see Photograph No. 11 in Appendix A)	
Two large silos marked “calcium carbonate” (see Photograph No. 12 in Appendix A)

Photograph No. 9
Orientation: Northeast
Description: Product storage tanks and floor drains in Specialty Minerals building.

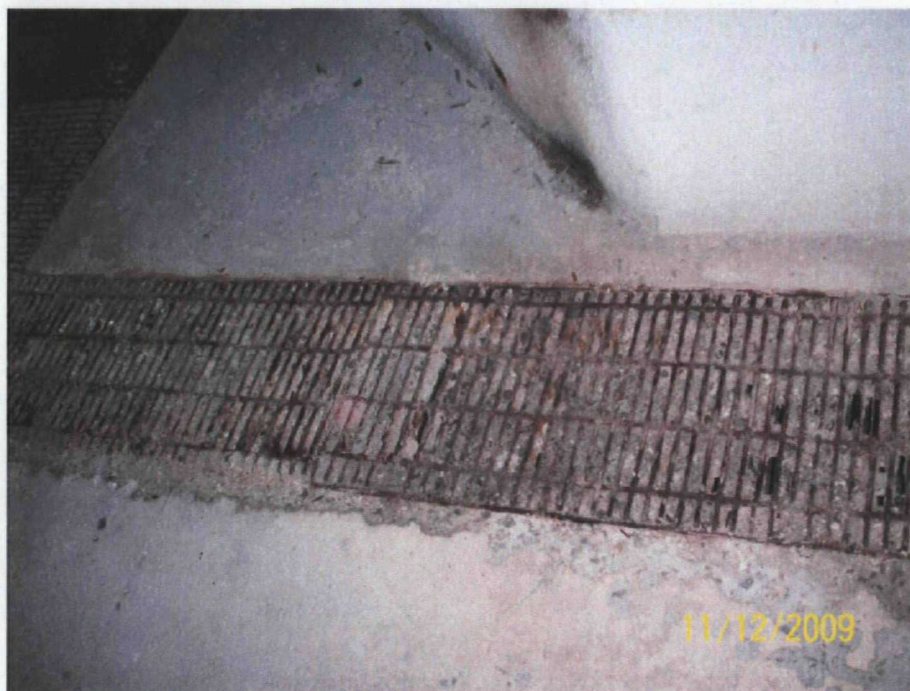
Photograph No. 10
Orientation: Overview
Description: Acid-damaged floor drain in Specialty Minerals building.

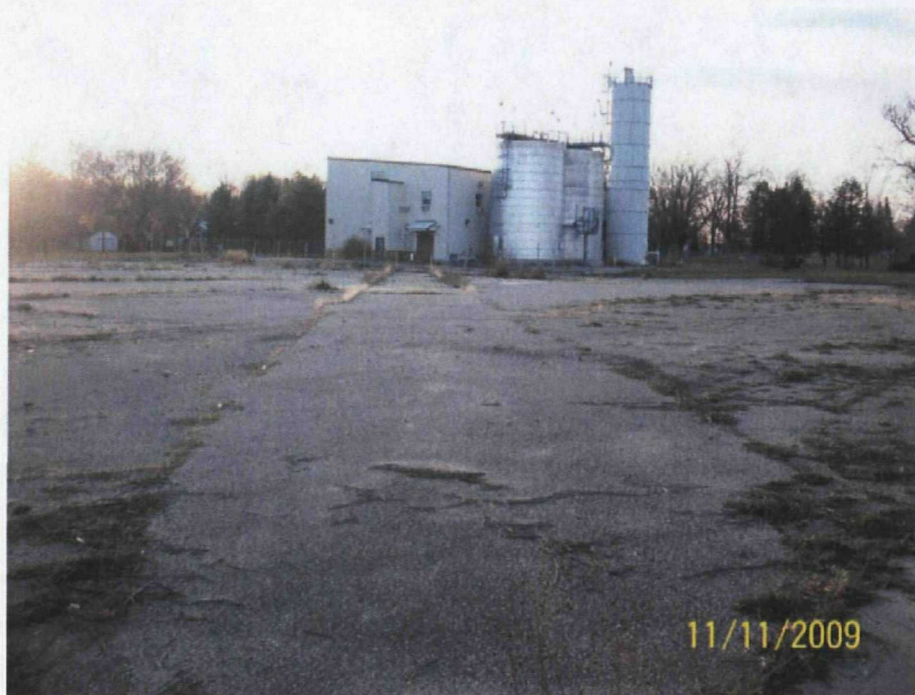
Photograph No. 11
 Orientation: Southwest
 Location: Plainwell Mill
 Date: November 11, 2009
 Description: Asphalt cuts extending from Specialty Minerals building toward the Mill building.

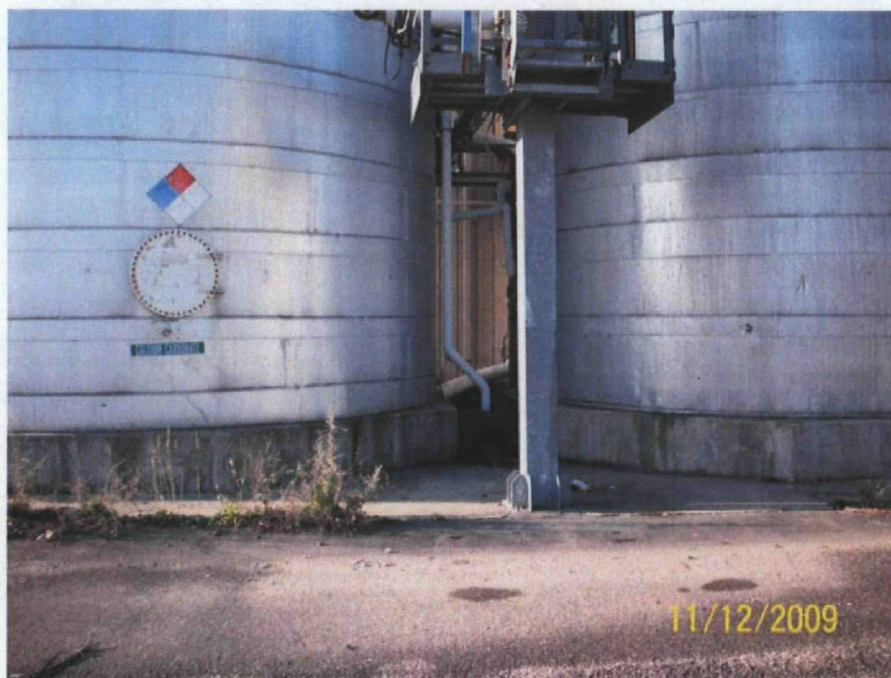
Photograph No. 12
 Orientation: South
 Location: Plainwell Mill
 Date: November 12, 2009
 Description: Calcium carbonate silos along north exterior wall of Specialty Minerals building.

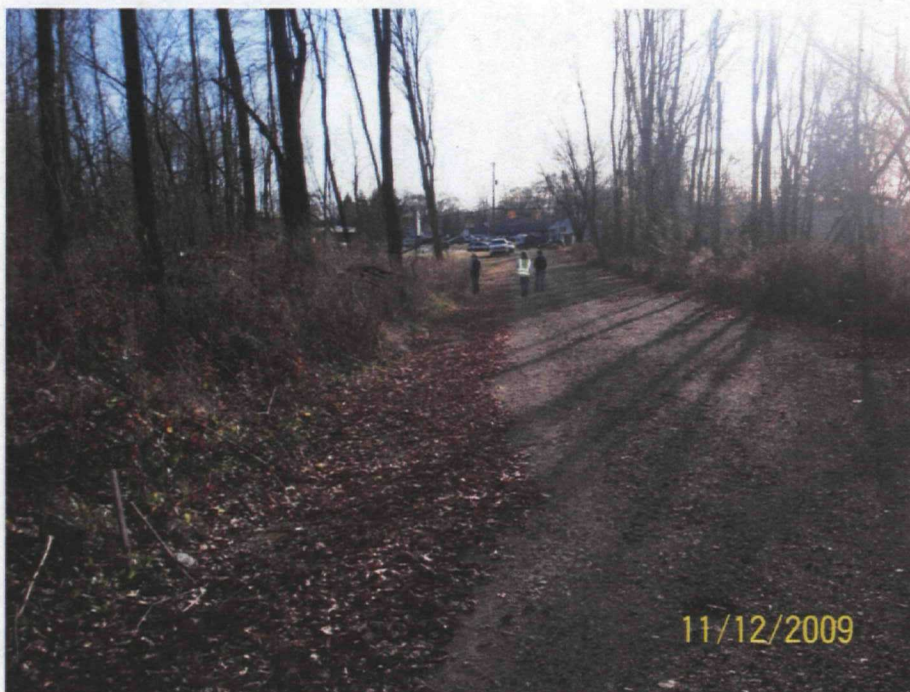
The last area to be staked was the wooded area located in Area 1 (see Photograph No. 13 in Appendix A). Chain-link fencing was present; therefore, about half of this area was inaccessible because the gate was locked. It was determined that sampling locations within the locked, fenced-in area could be staked at a later time, possibly concurrent with sampling activities. SulTRAC left the site around 3:30 p.m.

Photograph No. 13
Orientation: South
Description: Staking proposed soil sample locations in wooded area on west side of site.

- A portion of the wooded area in Area 1 was not accessible due to chain-link fencing. Therefore, proposed sampling locations SB-149, SB-150, and SB-152 still must be located and staked.
- CRA decided in the field to switch the locations of SB-139 and MW-15 near the former secondary clarifier. This change must be documented in the revised project plans to be submitted by CRA.
- A concrete structure (possibly an old foundation) was identified in Area 3 northeast of the Specialty Minerals building and southeast of the former Quality Products building. CRA personnel stated that they would propose sampling locations near the concrete structure.
- One proposed soil boring location in Area 3 near the coal tunnel (SB-308) cannot be accessed with a drill rig; therefore, hand augering was proposed.
